REPORT NUMBER 214-GTL-04-003

**SAFETY COMPLIANCE TESTING FOR  
FMVSS NO. 214S  
SIDE IMPACT PROTECTION (STATIC)**

**GENERAL MOTORS CORP.  
2004 CHEVROLET MALIBU, PASSENGER CAR  
NHTSA NO. C40102**

**GENERAL TESTING LABORATORIES, INC.  
1623 LEEDSTOWN ROAD  
COLONIAL BEACH, VIRGINIA 22443**

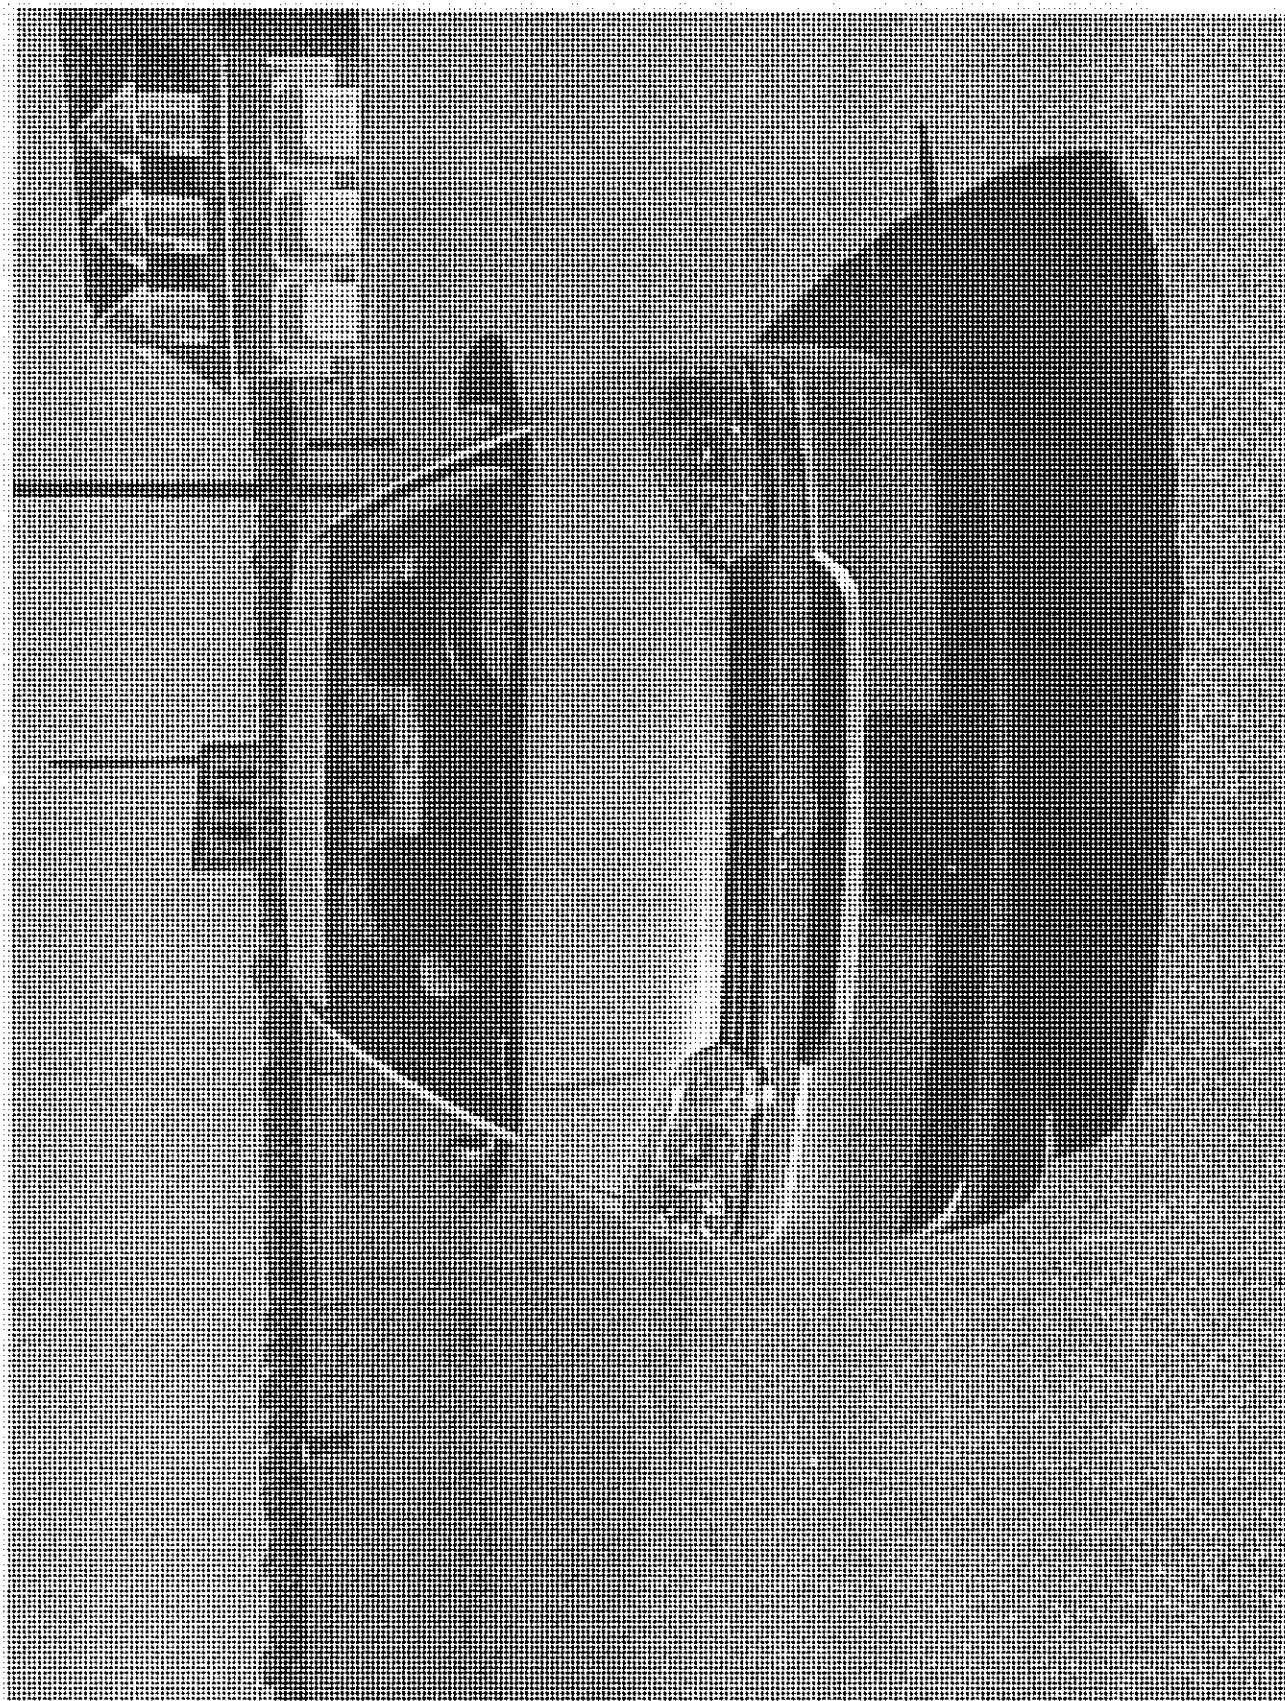
FIGURE 5.1  
FRONT VIEW OF VEHICLE PRE-TEST

| SECTION | | PAGE |
|---|---|---|
| | 5.1 Front View of Vehicle Pre-test | |

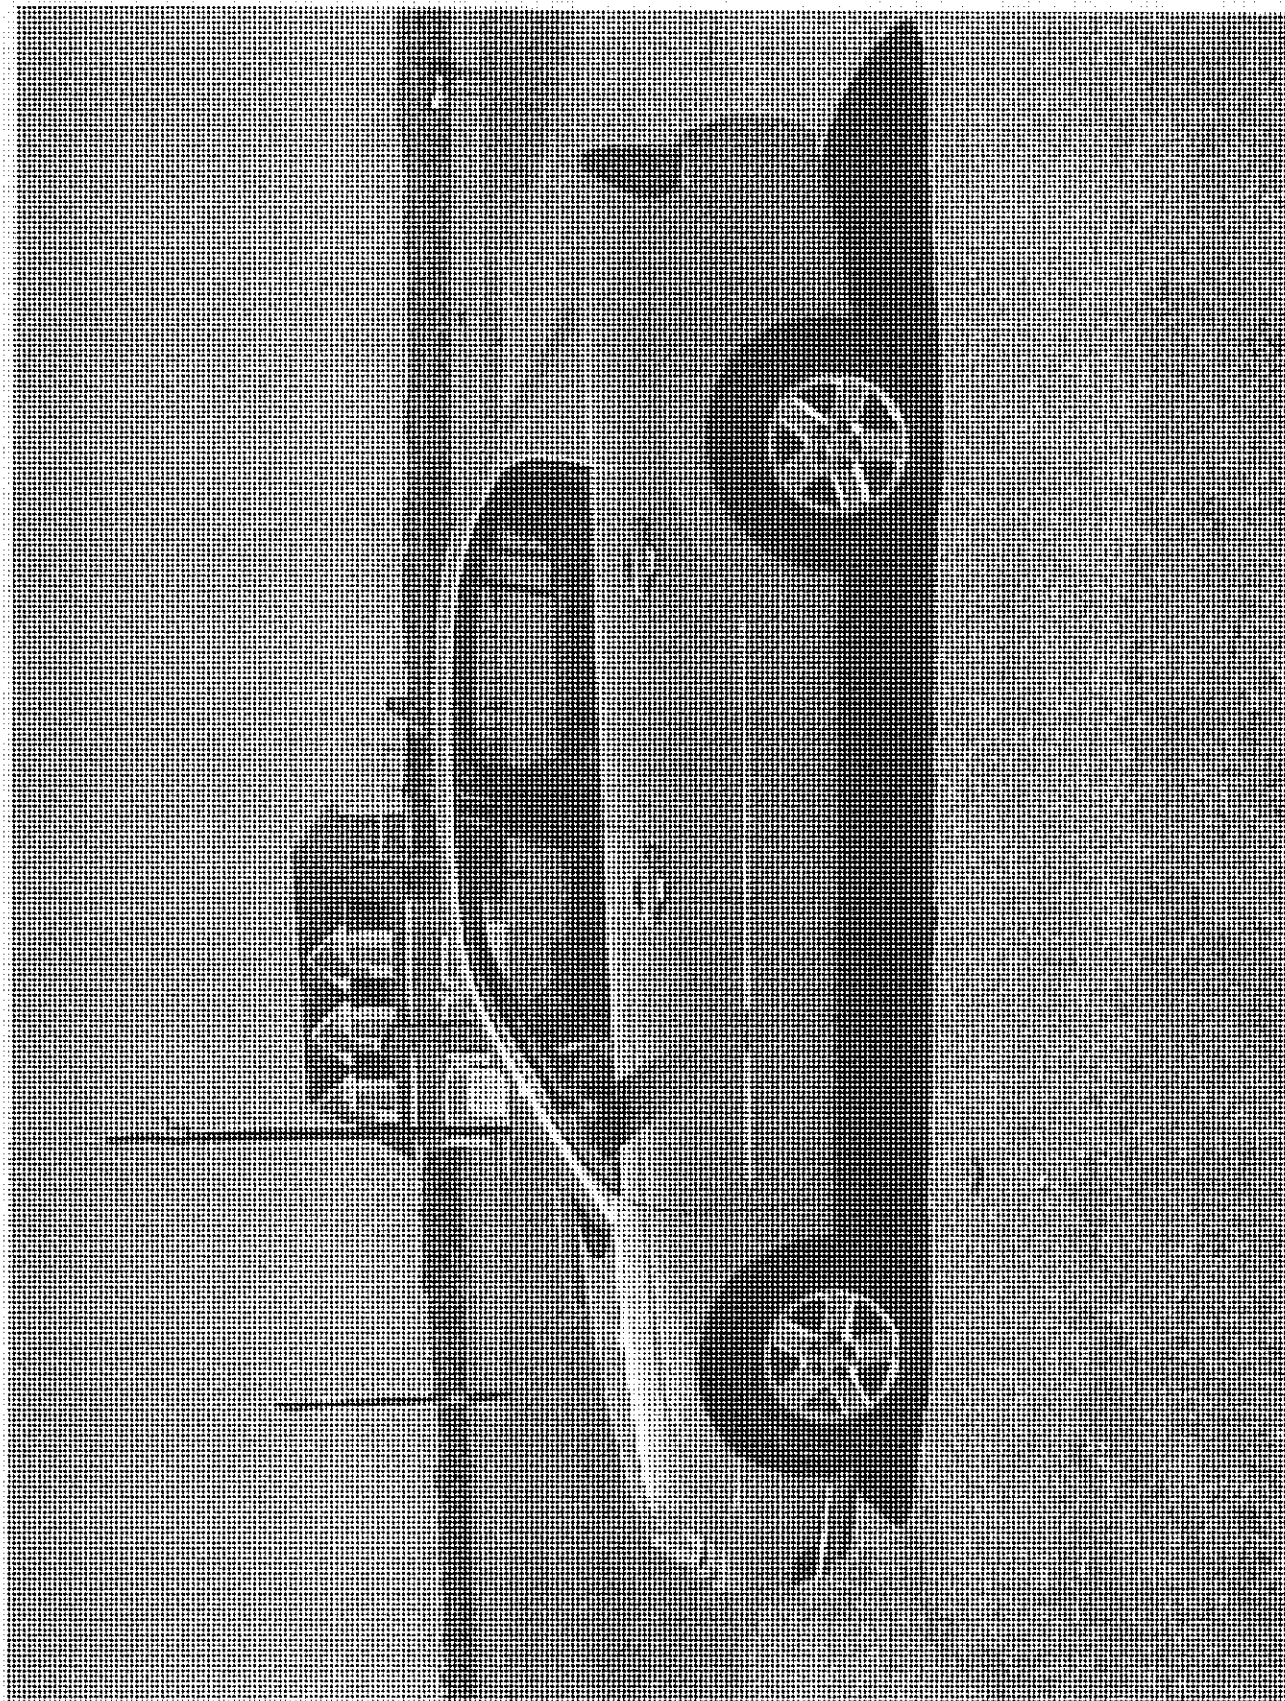
FIGURE 3.2  
LEFT SIDE VIEW OF VEHICLE PRE-TEST

| SECTION | | PAGE |
|---|---|---|
| | 5.2 Left Side View of Vehicle Pre-test | |

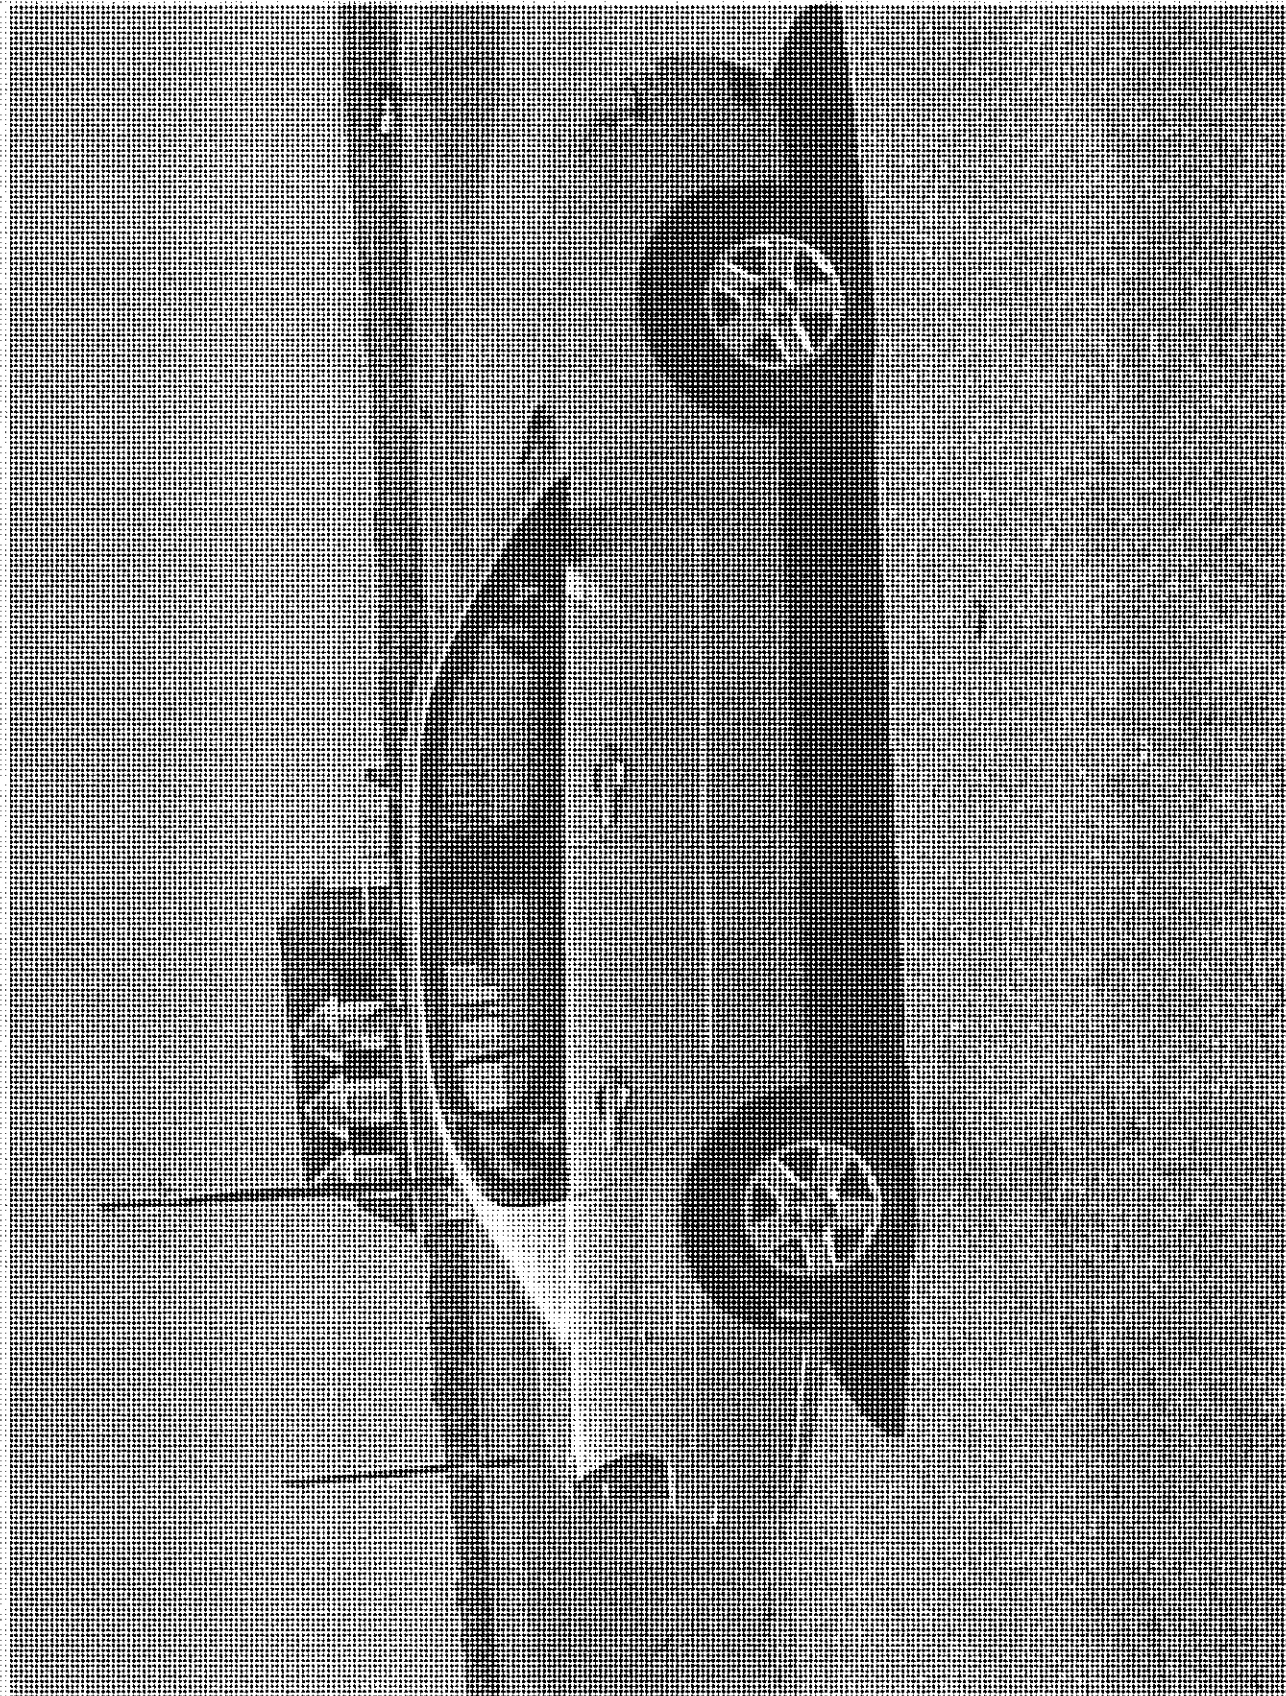
FIGURE 6.3  
RIGHT SIDE VIEW OF VEHICLE PRE-TEST

| SECTION | | PAGE |
|---|---|---|
| | 5.3 Right Side View of Vehicle Pre-test | |

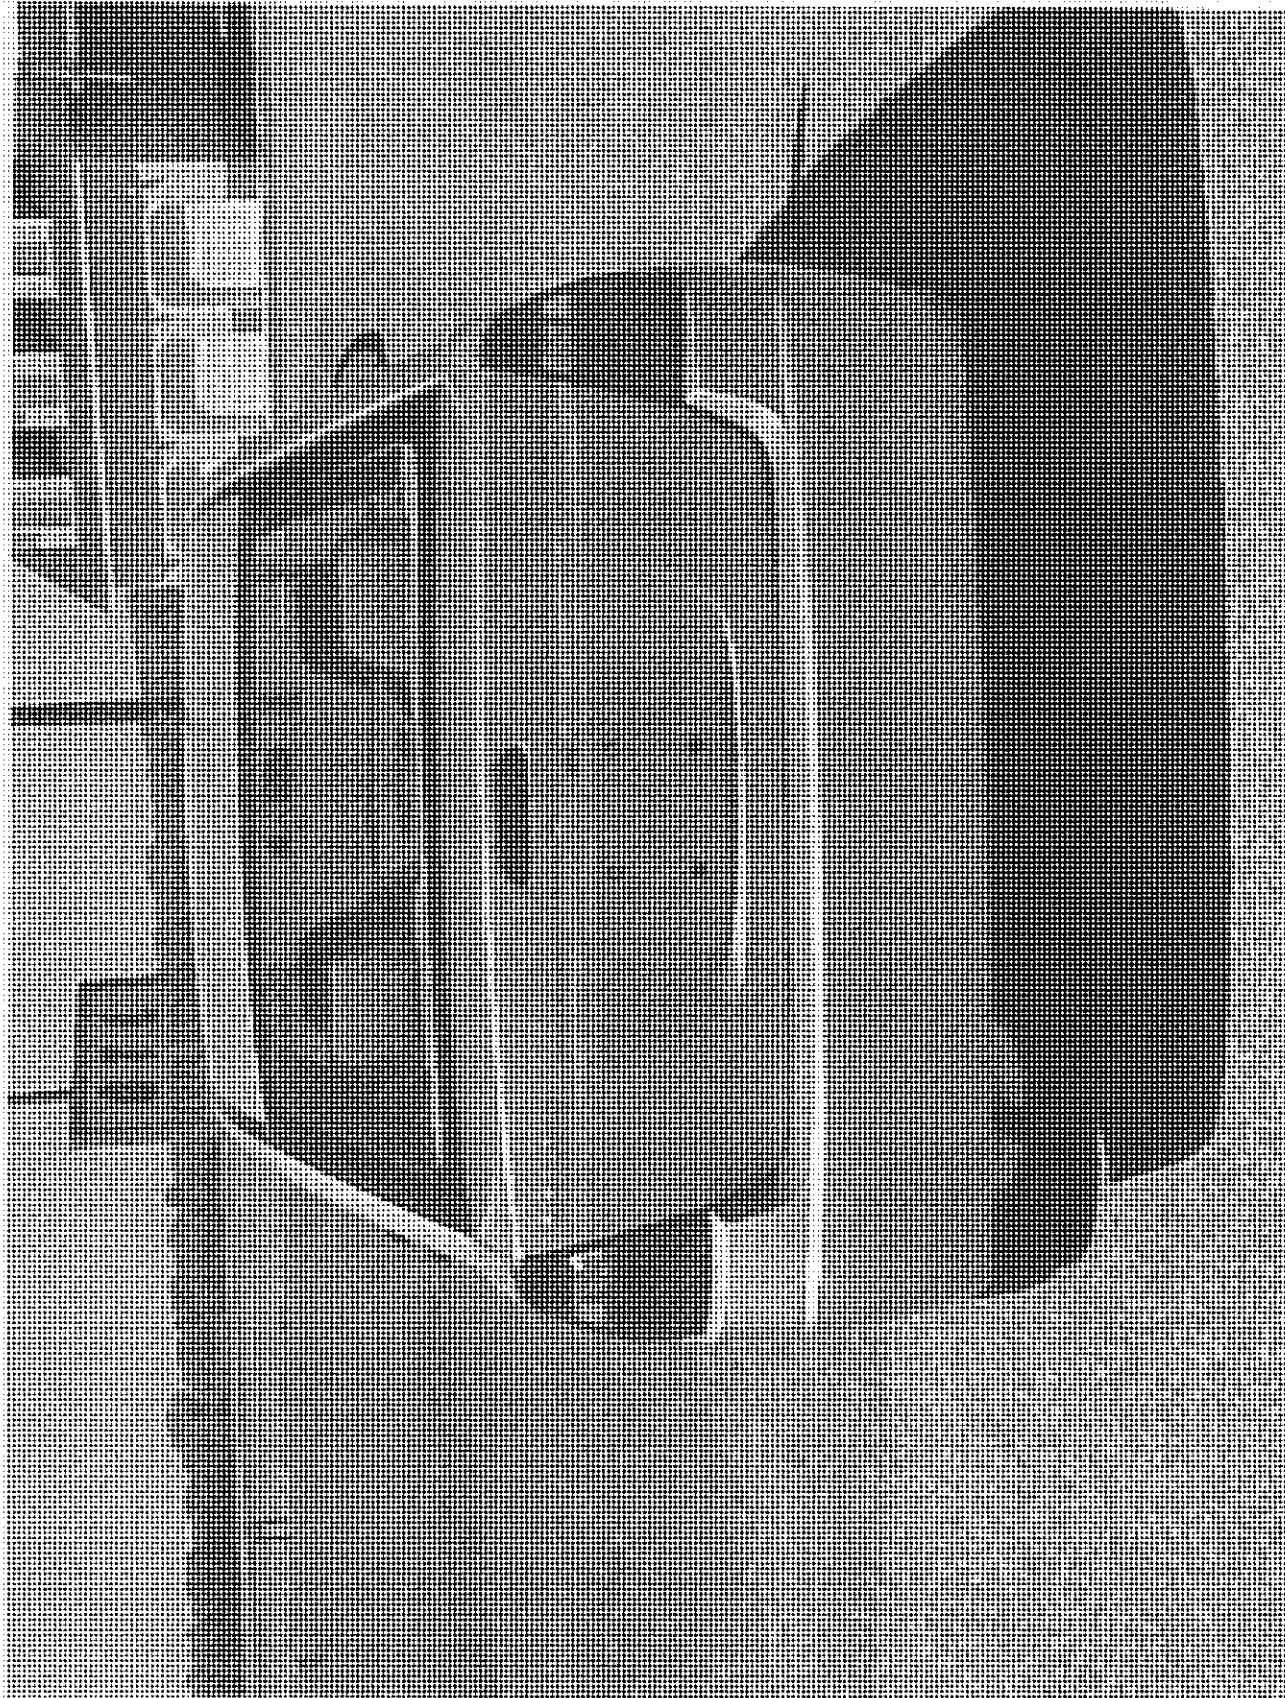
FIGURE 5.4  
REAR VIEW OF VEHICLE PRE-TEST

| SECTION | | PAGE |
|---|---|---|
| | 5.4 Rear View of Vehicle Pre-test | |

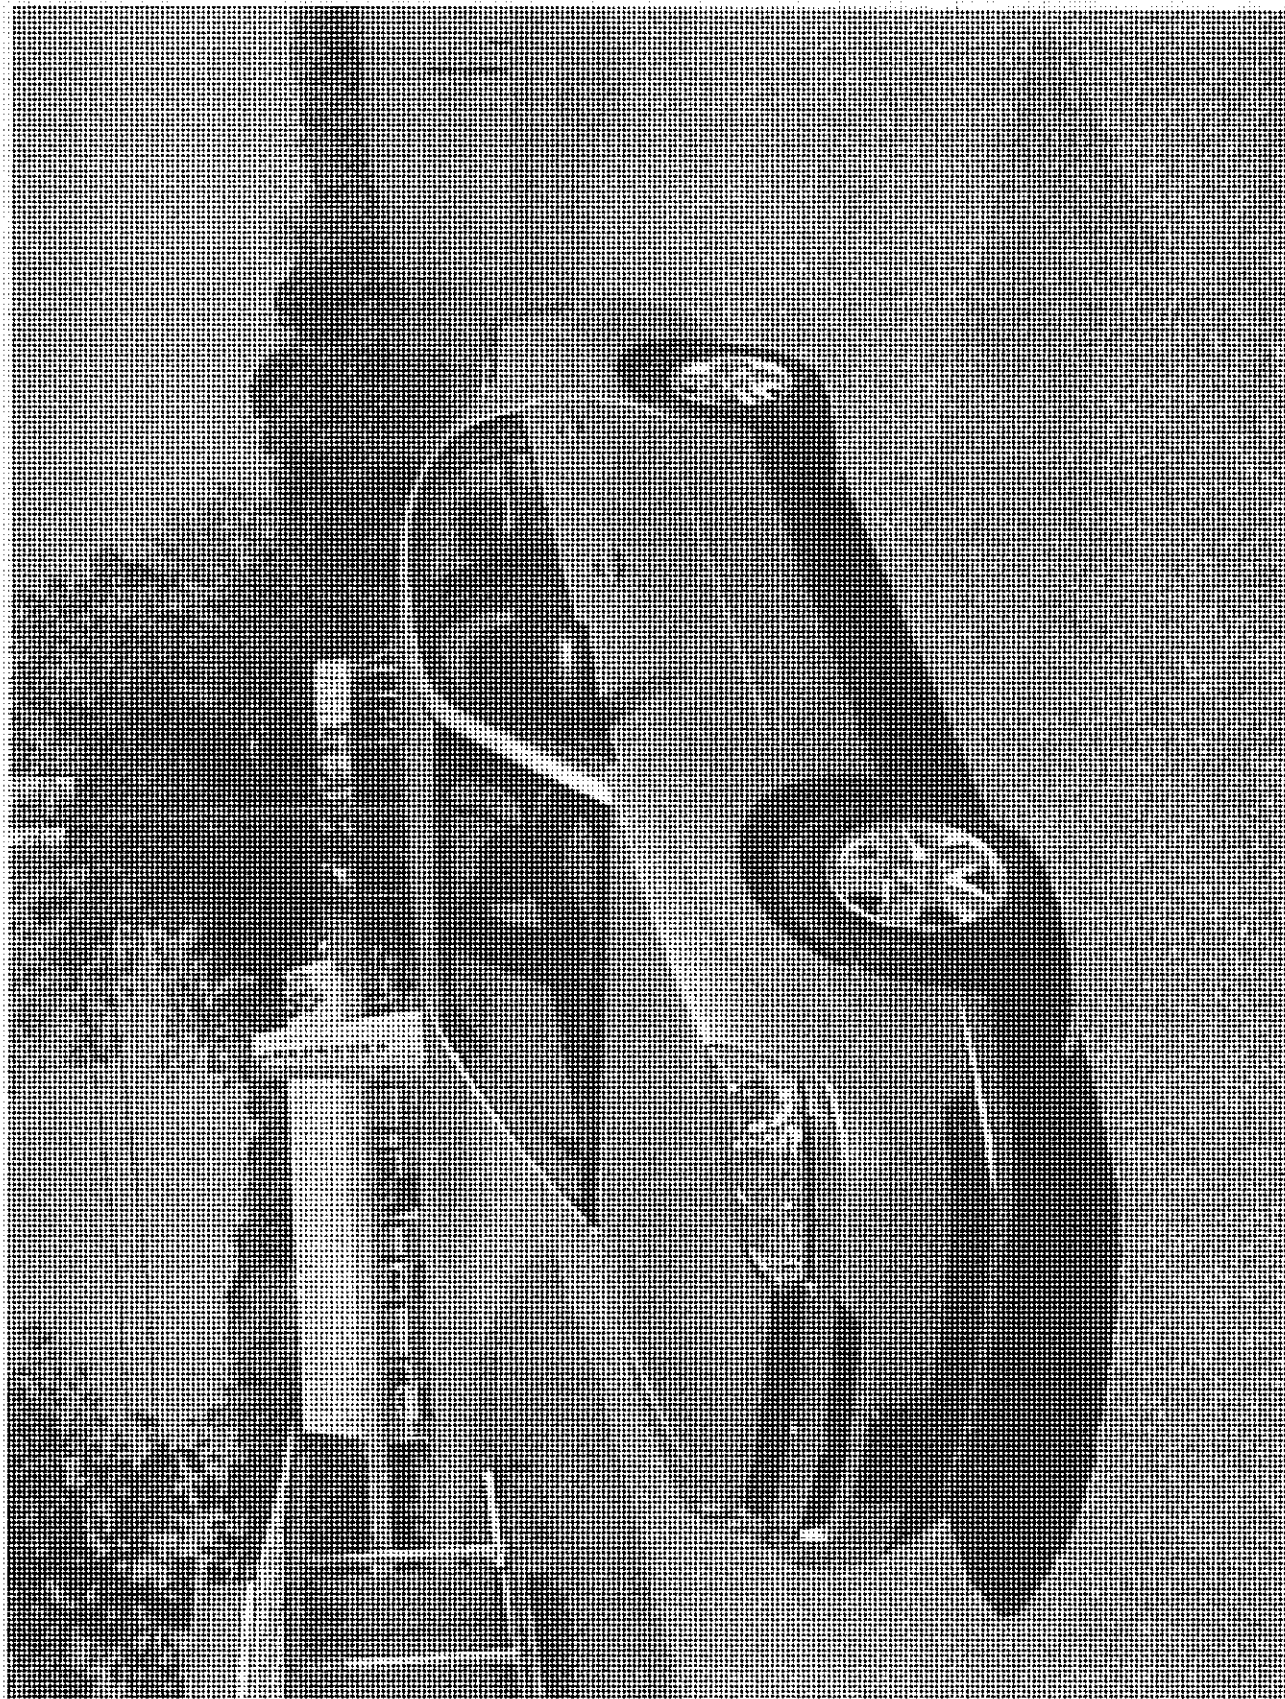
FIGURE 5.5  
¾ FRONTAL VIEW FROM LEFT SIDE OF  
VEHICLE PRE-TEST

| SECTION | | PAGE |
|---|---|---|
| | 5.5 3/4 Frontal View from Left Side of Vehicle Pre-test | |

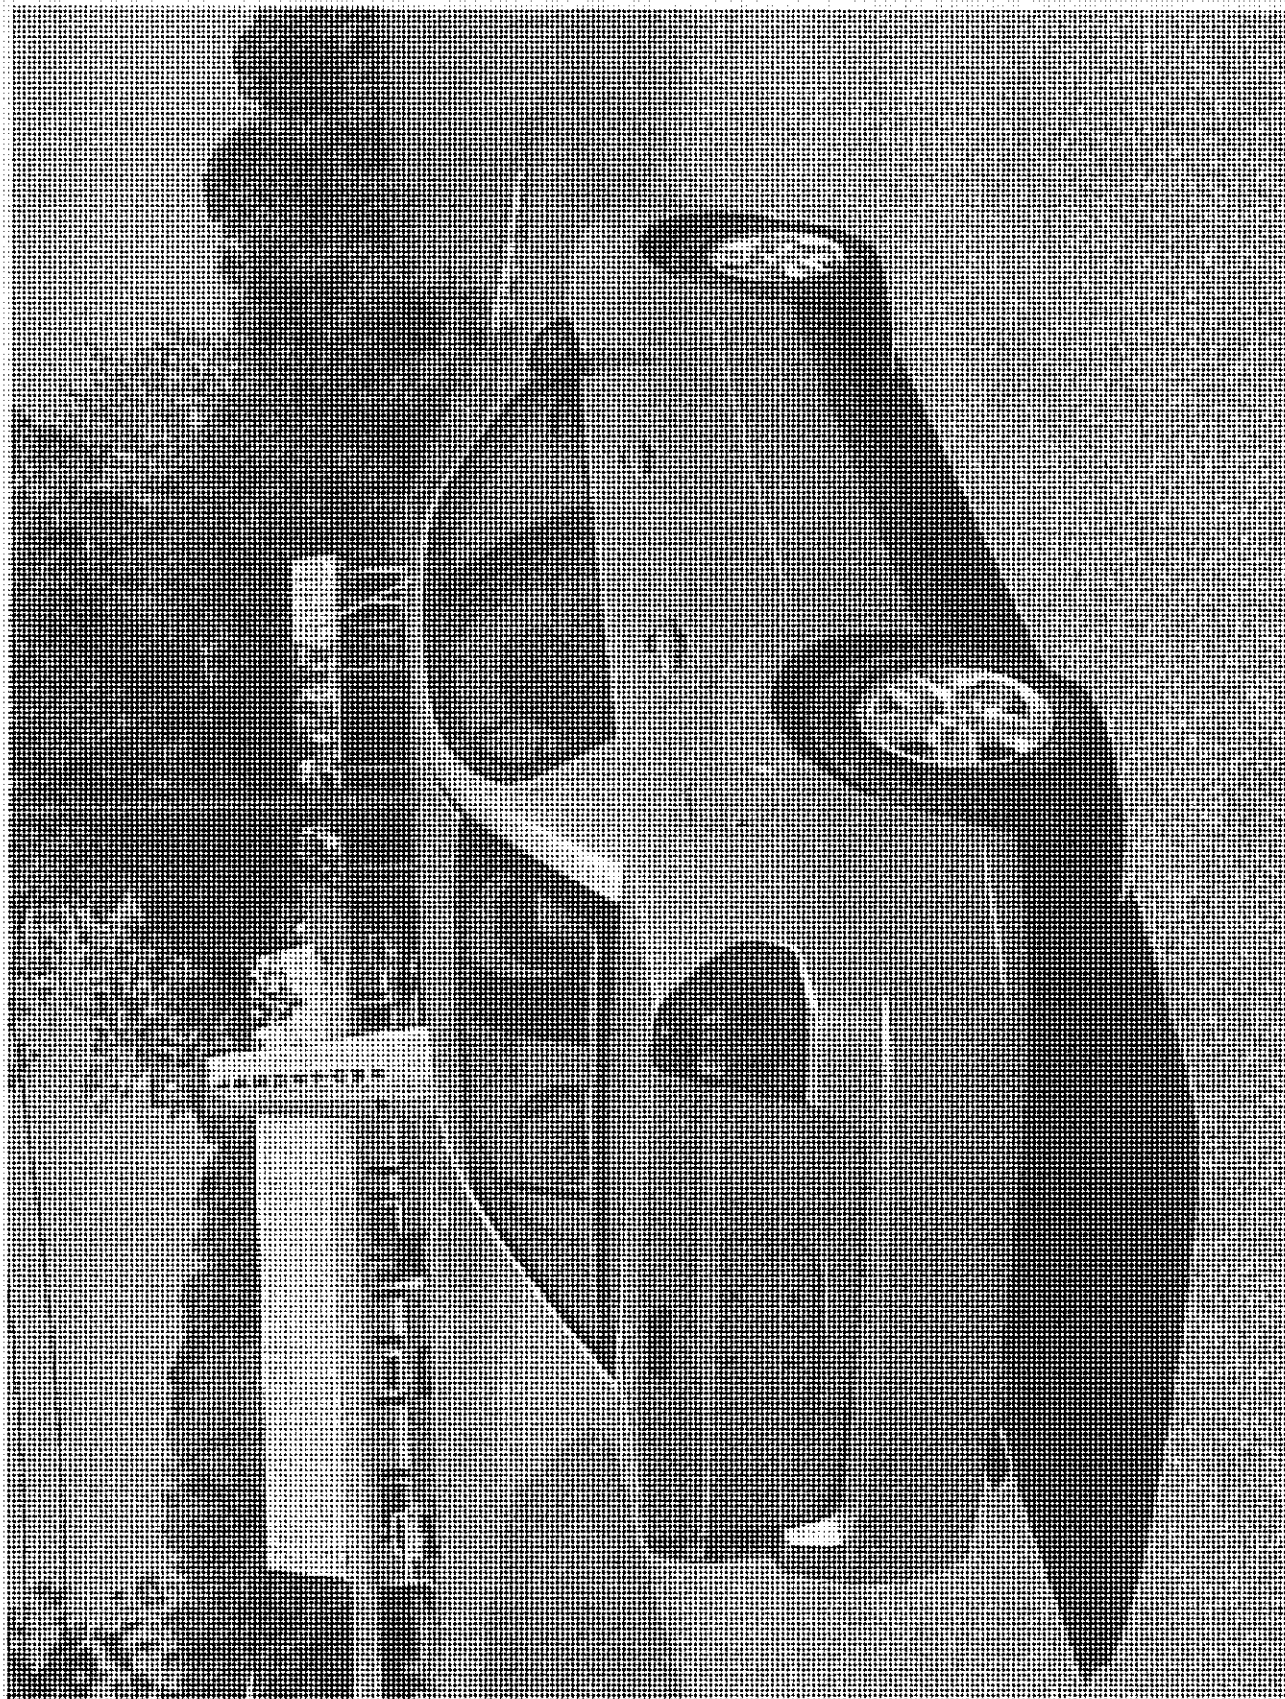
FIGURE 5.6  
¾ REAR VIEW FROM RIGHT SIDE OF  
VEHICLE PRE-TEST

| SECTION | | PAGE |
|---|---|---|
| | 5.6 3/4 Rear View from Right Side of Vehicle Pre-test | |

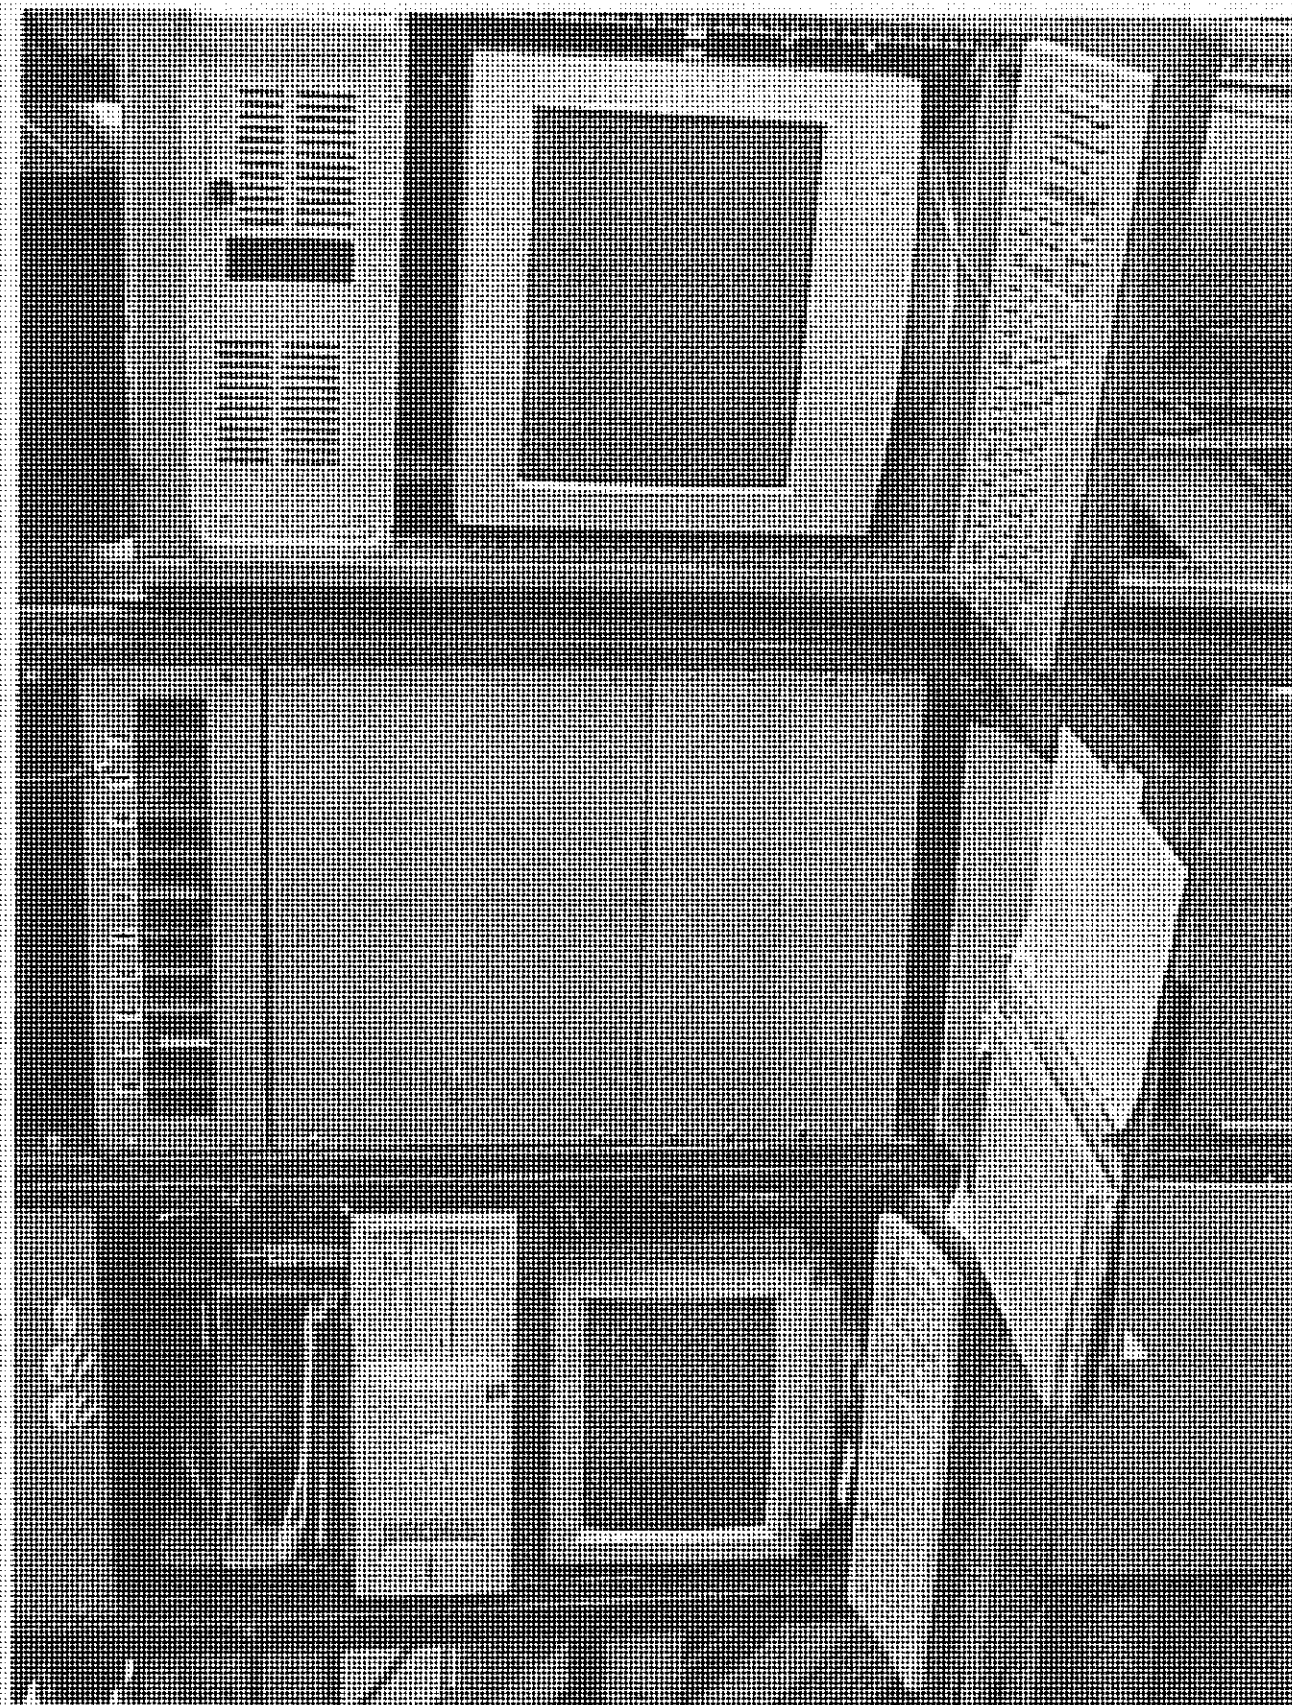
FIGURE 5.10  
INSTRUMENTATION SET-UP

| SECTION | | PAGE |
|---|---|---|
| | 5.10 Instrumentation Setup | |

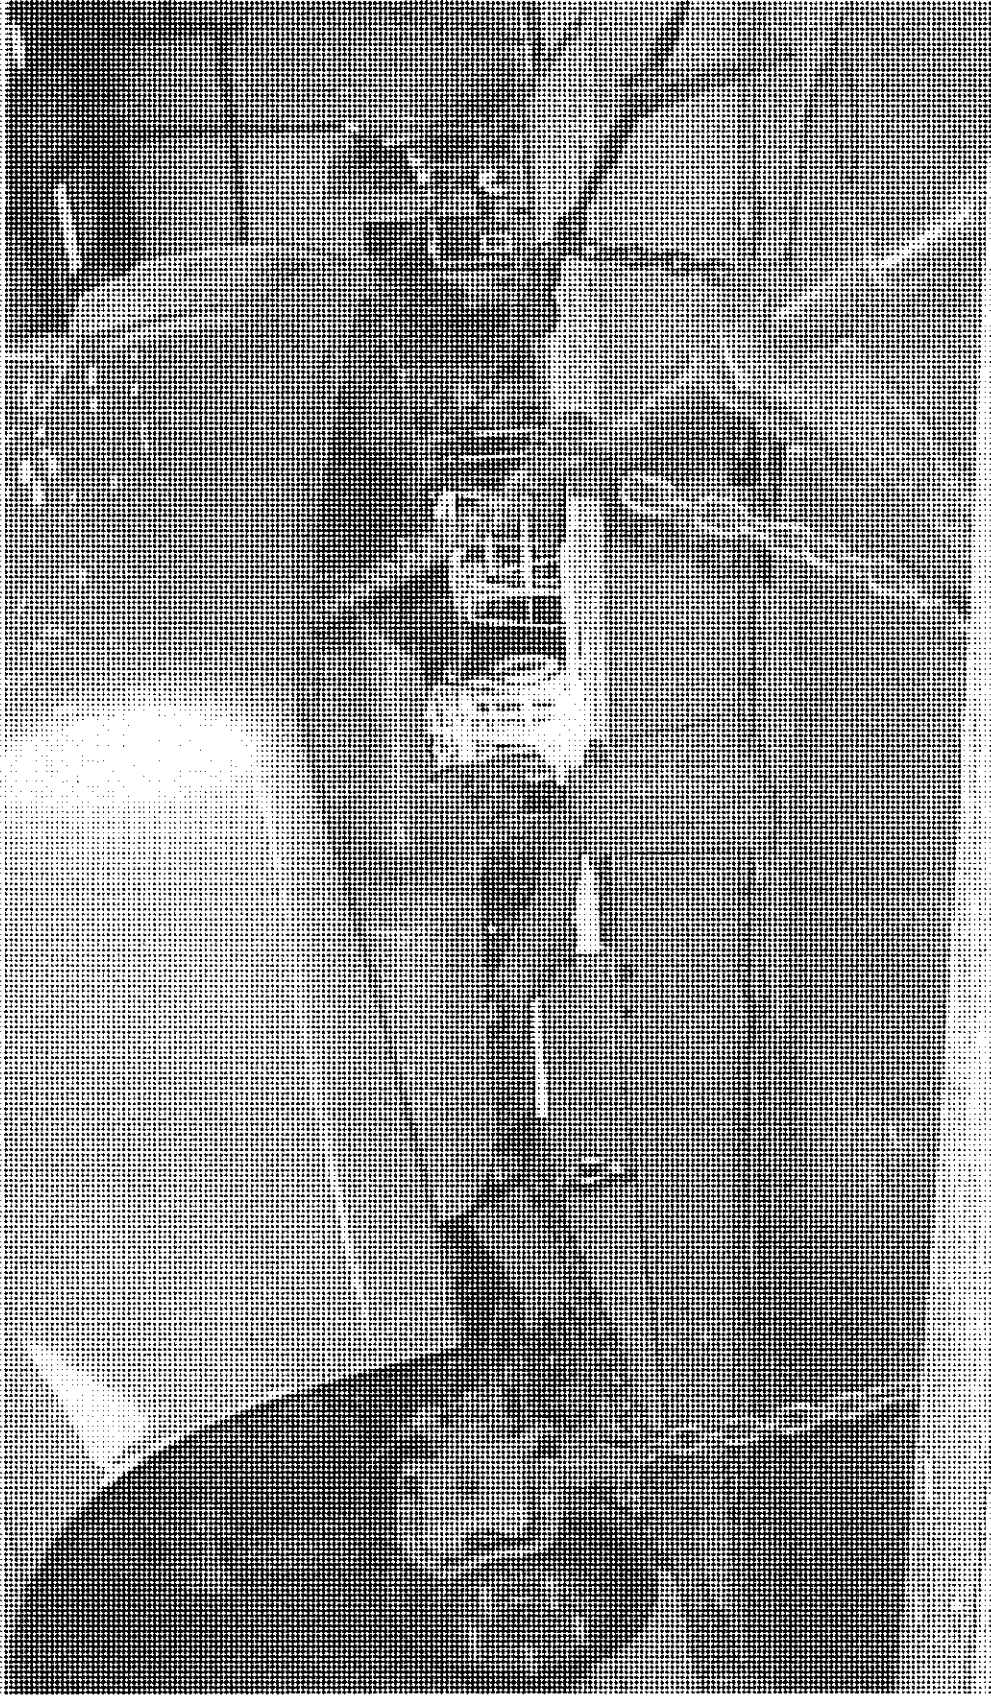
FIGURE 5.11  
REAR VEHICLE TIE DOWN - TEST 1

| SECTION | | PAGE |
|---|---|---|
| | 5.11 Rear Vehicle Tie Down - Test 1 | |

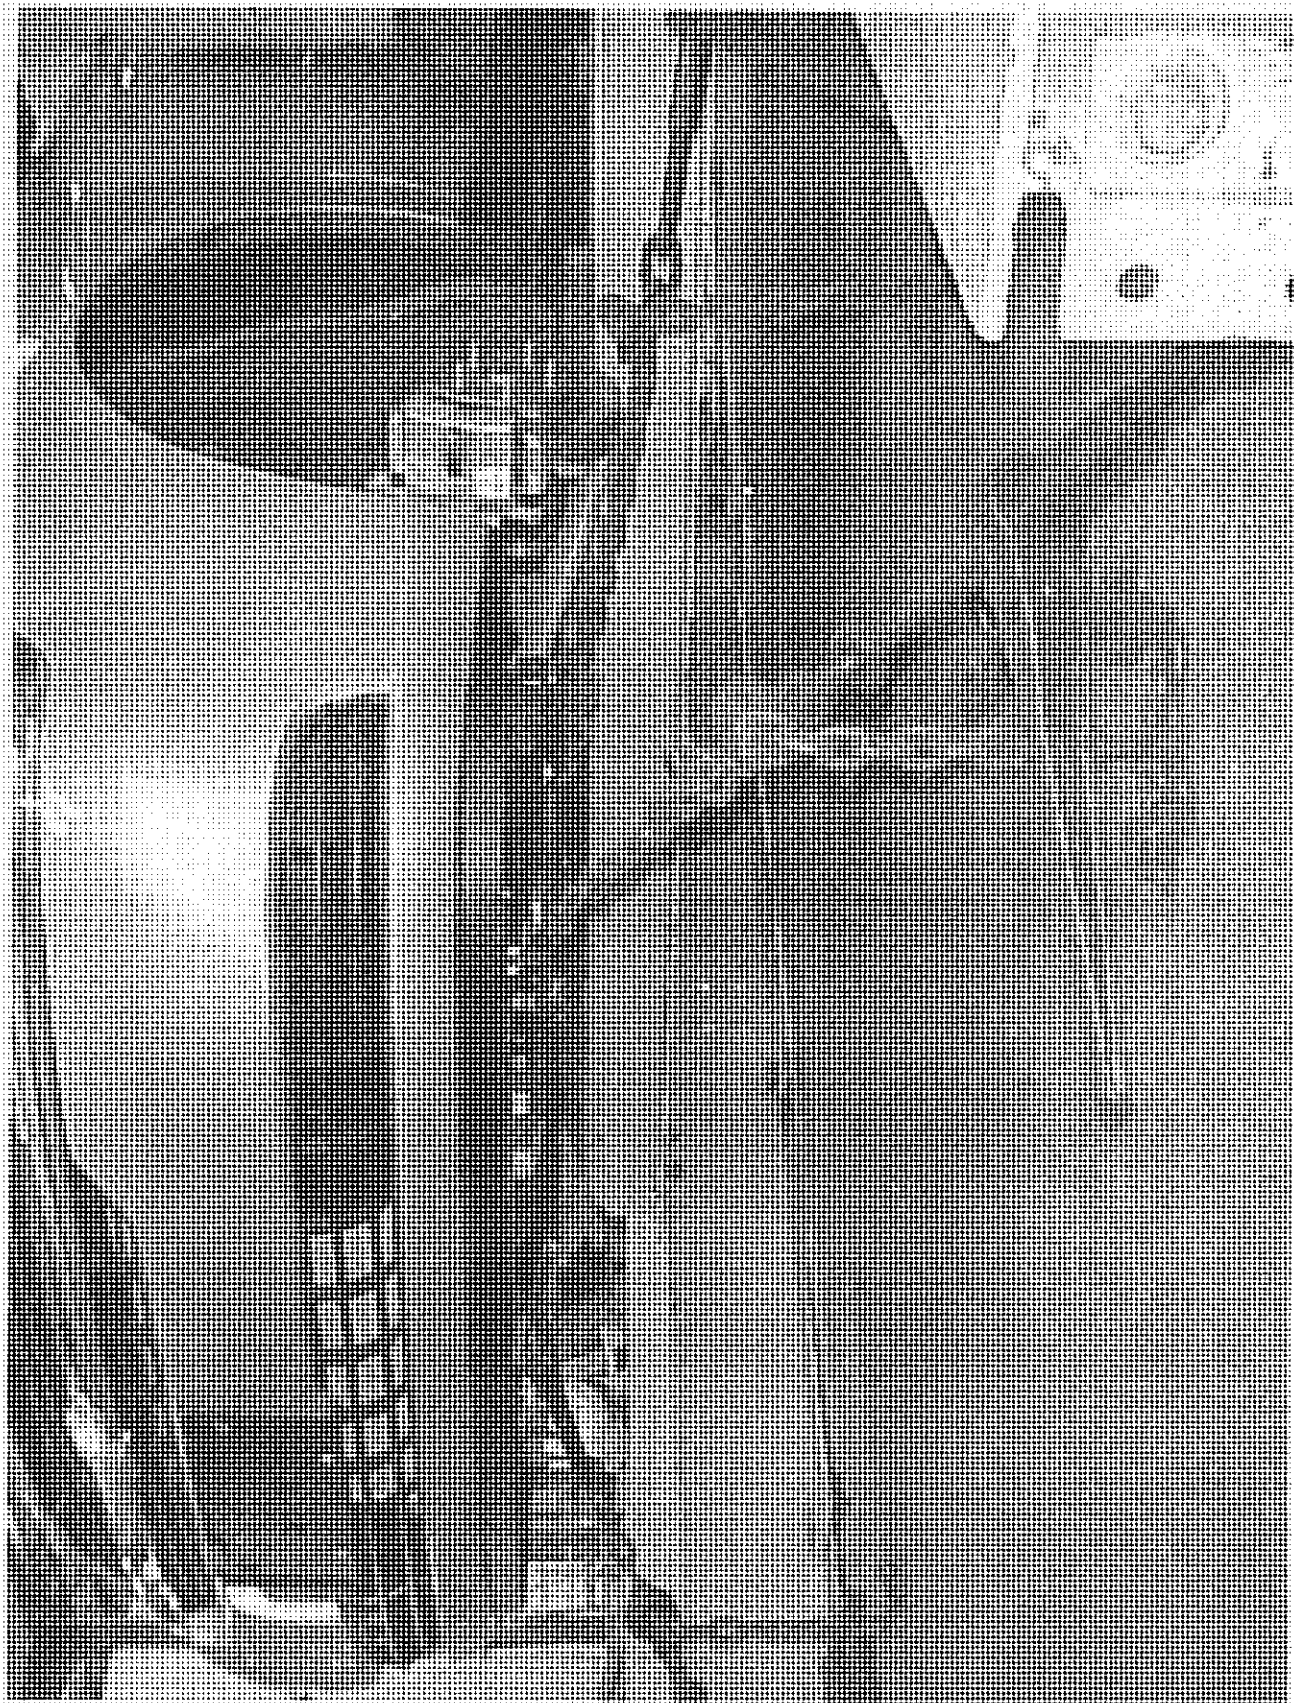
FIGURE 5.12  
FRONT VEHICLE TIE DOWN -- TEST 1

| SECTION | | PAGE |
|---|---|---|
| | 5.12 Front Vehicle Tie Down - Test 1 | |

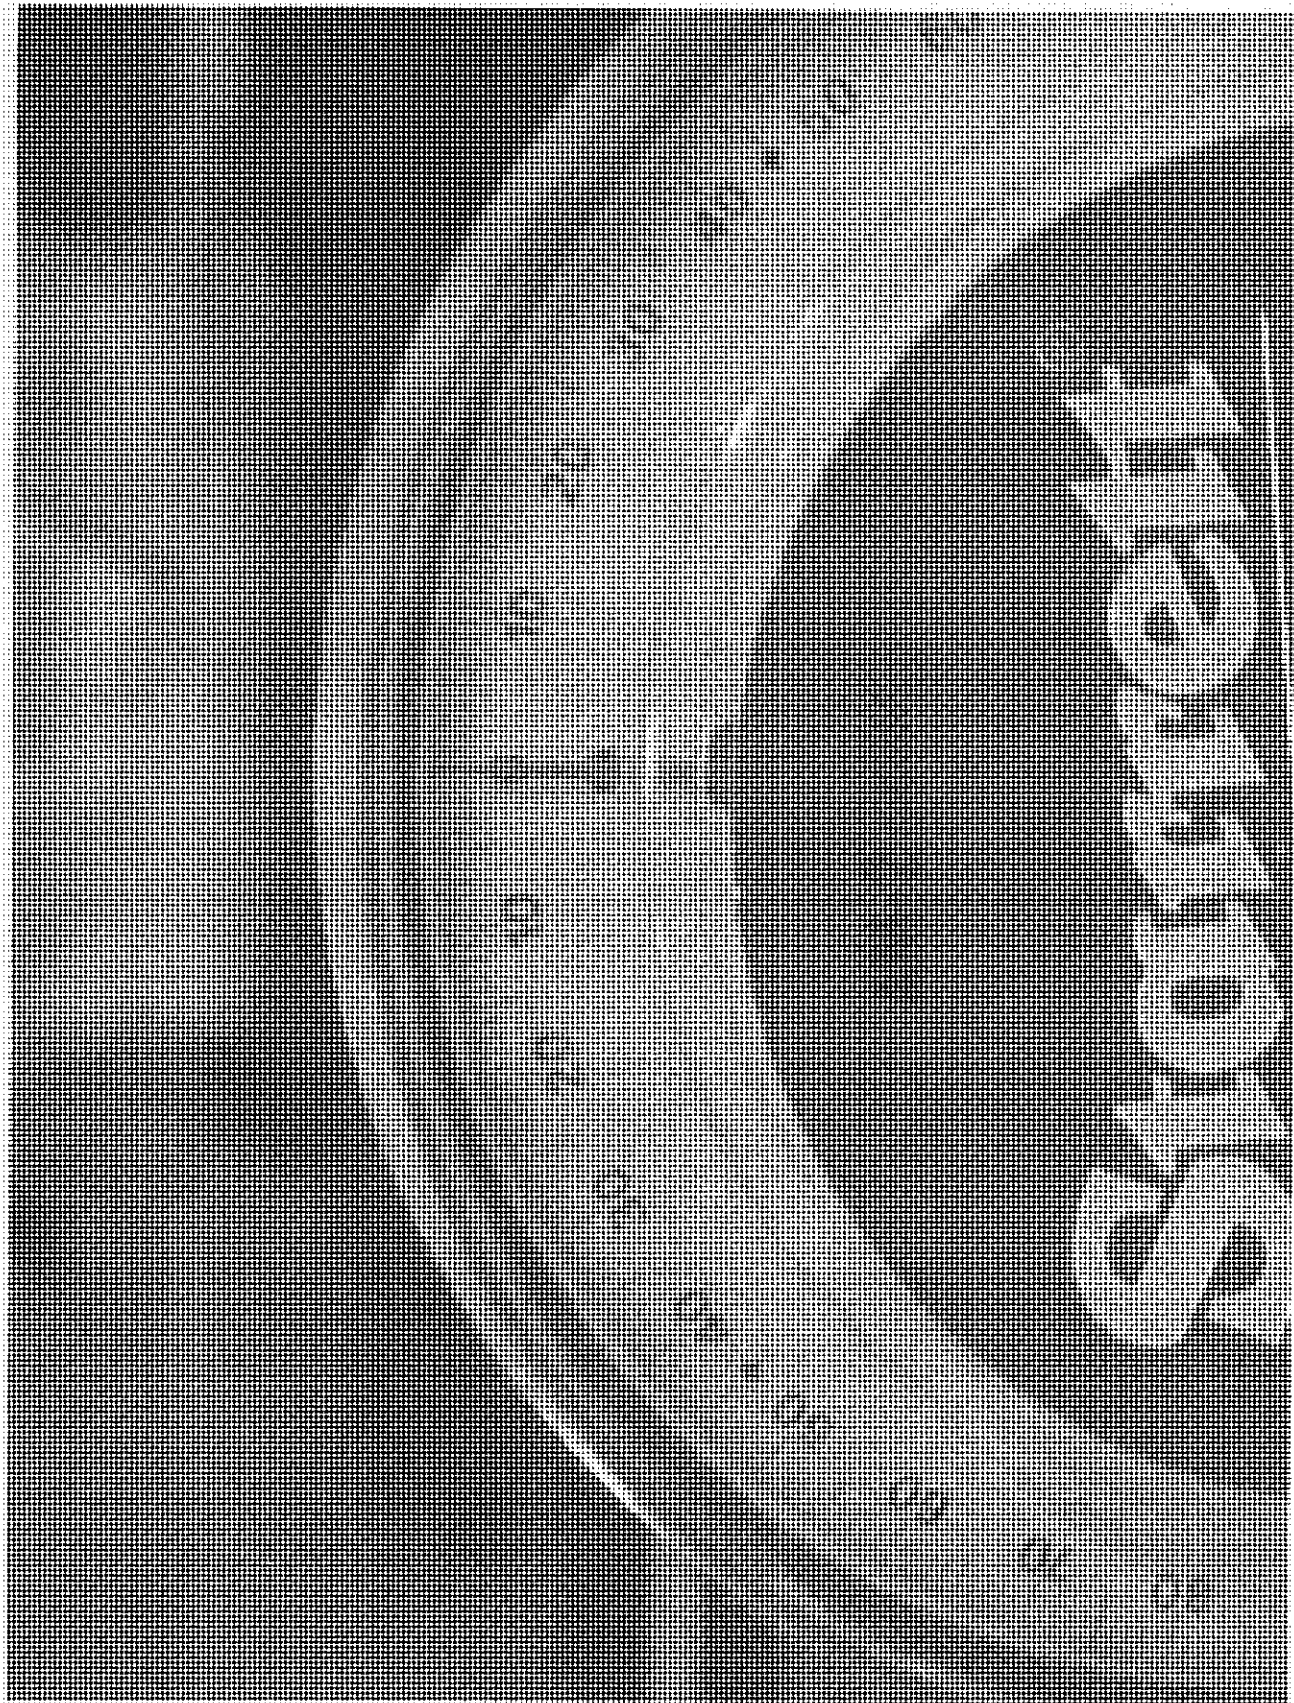
FIGURE 5.13  
INCLINOMETER PRE-TEST 1

| SECTION | | PAGE |
|---|---|---|
| | 5.13 Inclinator Pre-Test 1 | |
